# **Pentium® II Xeon™ Processor Specification Update**

Release Date: June 29<sup>th</sup>, 1998

Order Number: 243776-003

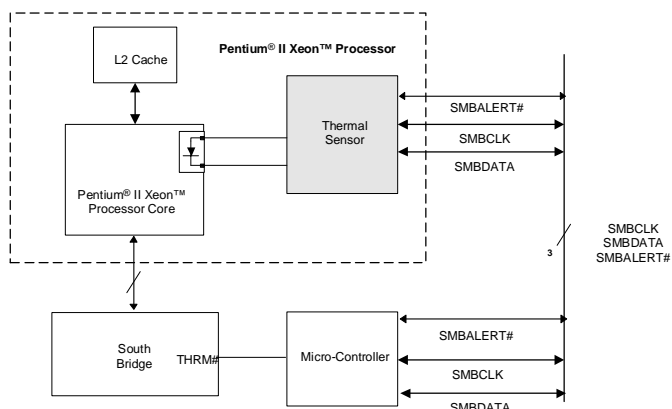
**Figure 1. An Example of Micro-controller Driven Thermal Management**

**PROBLEM:** The Pentium II Xeon processor has a thermal sensor that monitors the processor core's temperature. The thermal sensor asserts SMBALERT# if the processor temperature exceeds the temperature limits set in the Alarm Threshold Registers ( $T_{HIGH}$ ,  $T_{LOW}$ ). It also sets the corresponding Status Register bits to identify the cause of the interrupt. Figure 1 gives one example of the how the SMBALERT# signal could be used in a system.

Under the conditions described below, the thermal sensor incorrectly generates the SMBALERT# interrupt. All of the following conditions must be met to trigger a false interrupt:

**WORKAROUND:** Three different (mutually exclusive) workarounds are possible:
